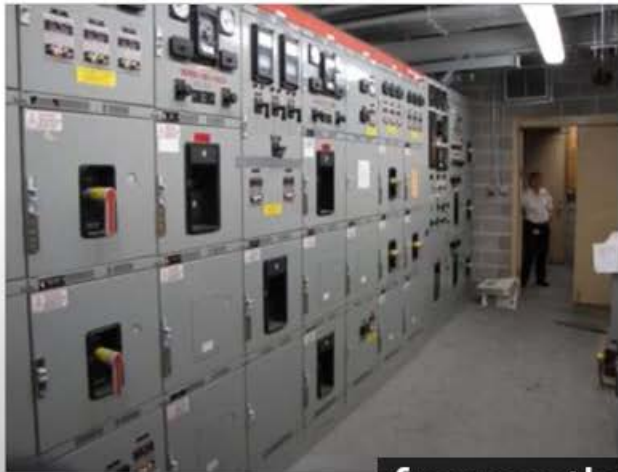
0-25% Damage (Up to 12" above FFE)

Minor electrical components and limited wiring inundated, flooding below normal receptacle/outlet height

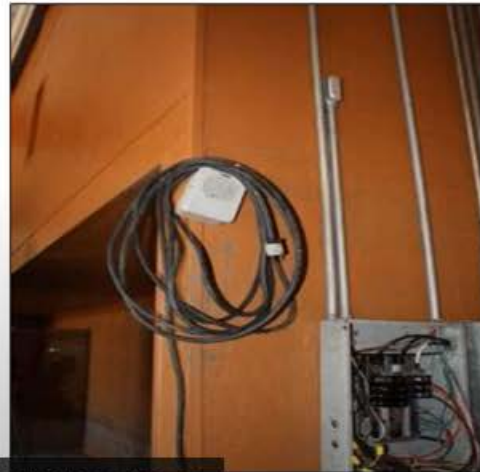
25-50% Damage (12" to 18" above FFE)

Receptacles impacted, major components of the electrical system not affected

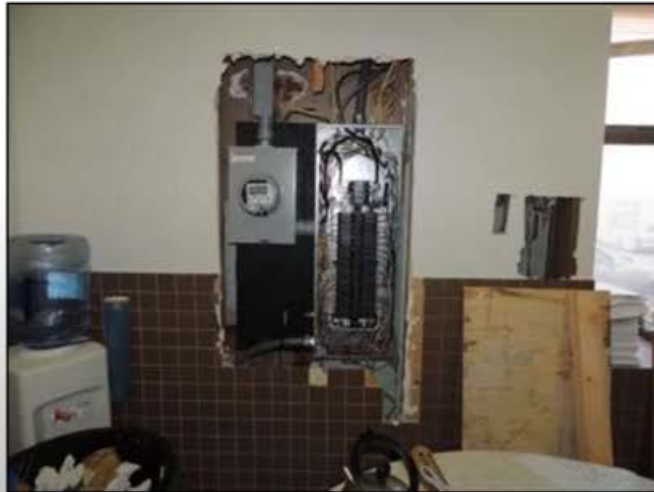
50-75% Damage (18" to 3' above FFE)

Significant receptacle/wire damage;
flooding above normal switch height

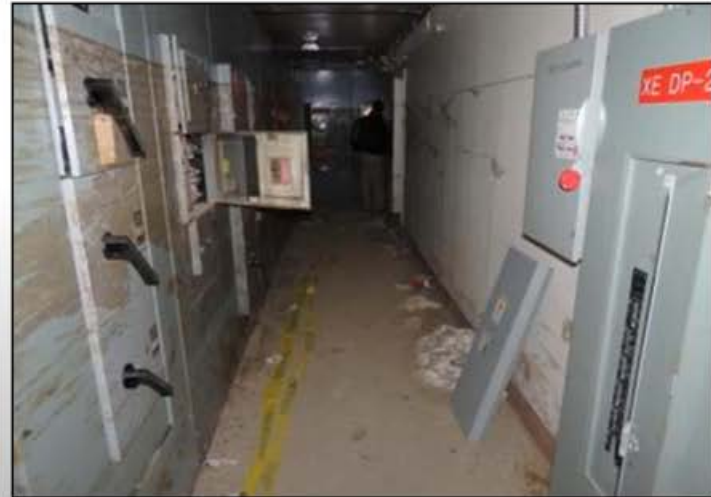
Over 75% Damage (Over 3' above FFE)

Most wiring components and significant
amount of electrical system is inundated
and needs replacement

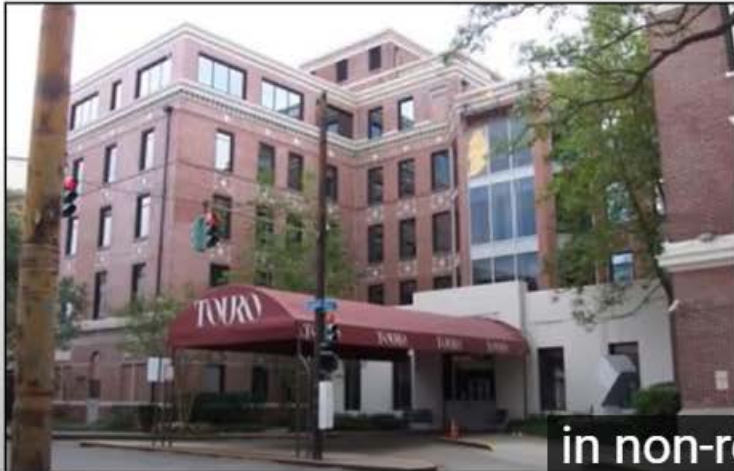
0-25% Damage (Up to 4' above FFE)

Limited scouring, no noticeable cracks in slab, minor damages to elements located below elevated floor

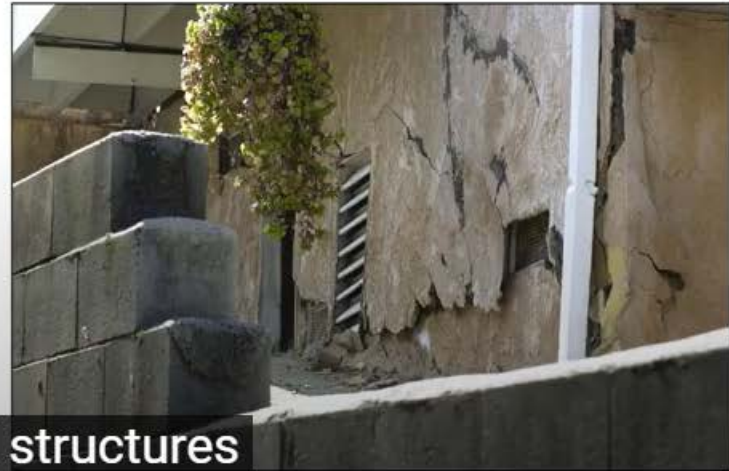
25-50% Damage (4' to 7' above FFE)

Limited scour, erosion, undermining or cracking, but no displacement of slab/walls

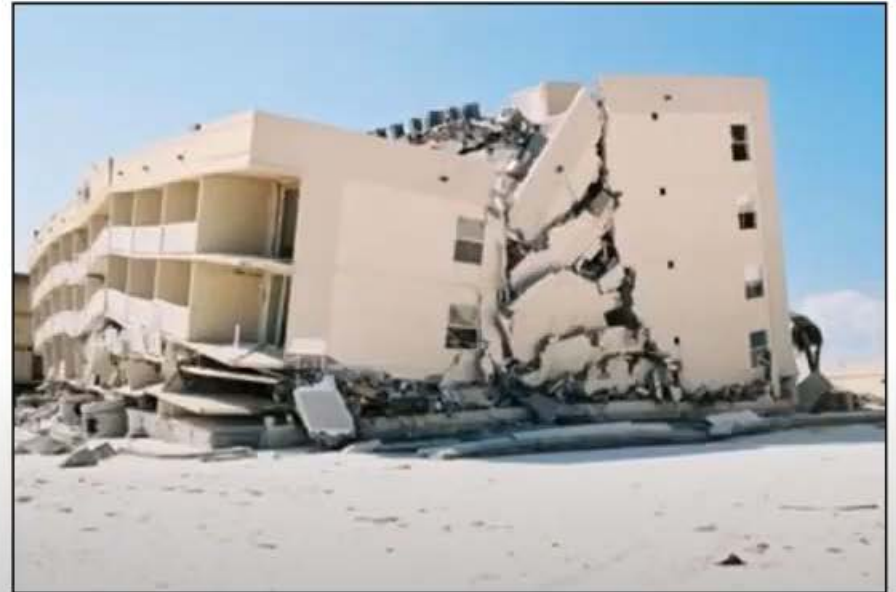
Over 75% Damage (over 10' above FFE)

Foundations cracked, displaced, or missing, major surge/wave damage, partial or complete structural collapse

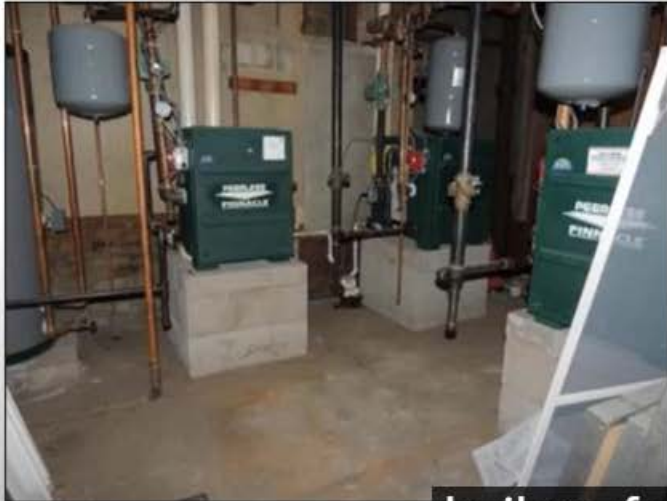
0-25% Damage (Up to 6" above FFE)

Fix condenser unit if at finished floor level;
remove and replace inundated
crawl space ducts

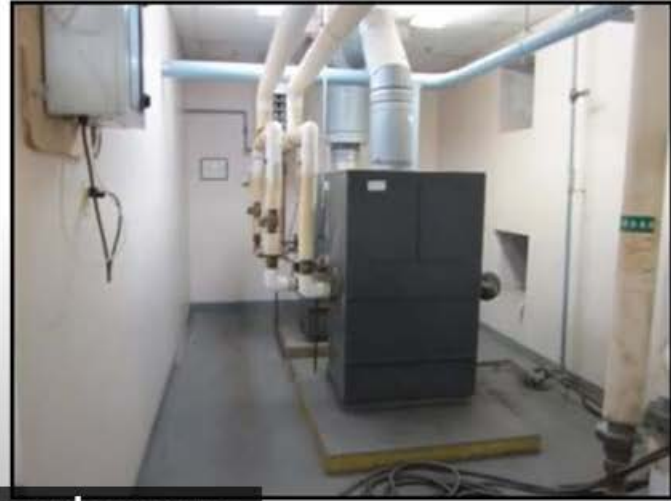
25-50% Damage (6" to 12" above FFE)

Damage/destruction to HVAC equipment
at or near grade

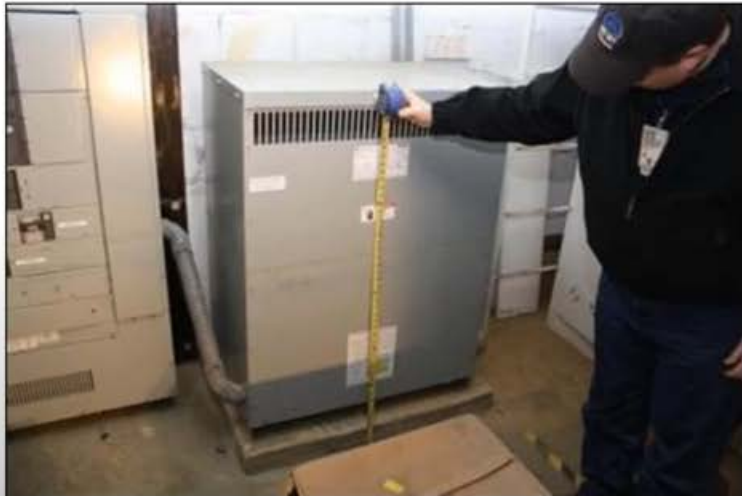
50-75% Damage (12" to 3' above FFE)

**Some HVAC equipment needs replacement;
remove/replace inundated ducts, insulation**

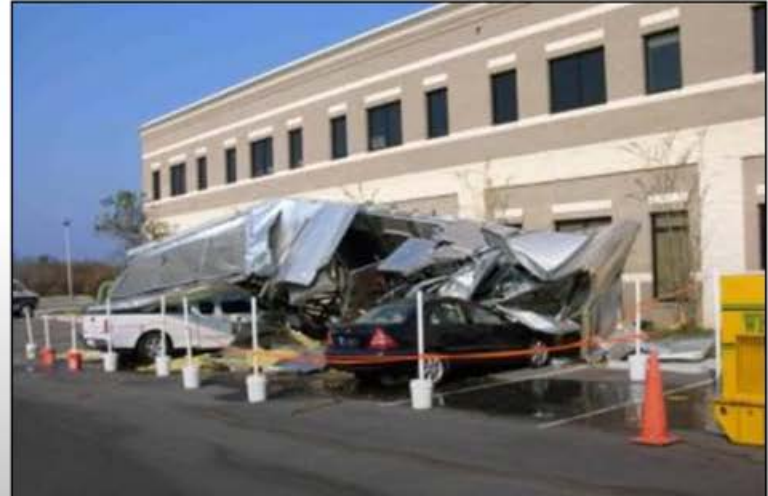
Over 75% Damage (Over 3' above FFE)

**All HVAC equipment, inundated ducts,
and duct insulation replaced**

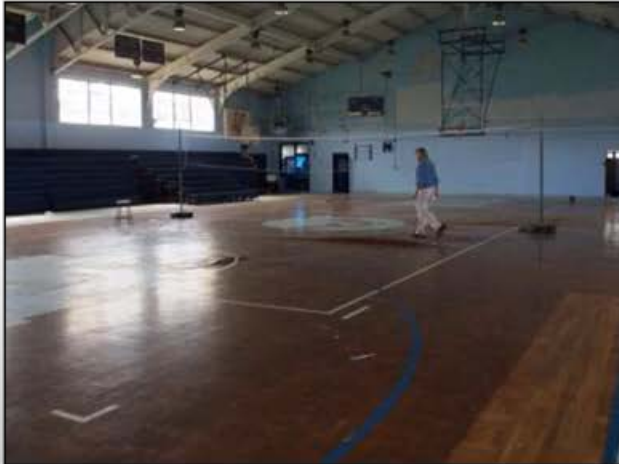
0-25% Damage (Just below FFE)

Possible water stains or damage at baseboard, bottoms of door casings

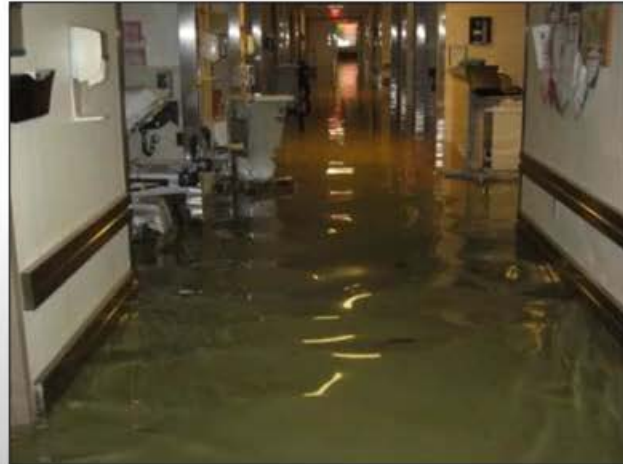
25-50% Damage (0" to 6" above FFE)

Likely water stains, damage to several areas inside

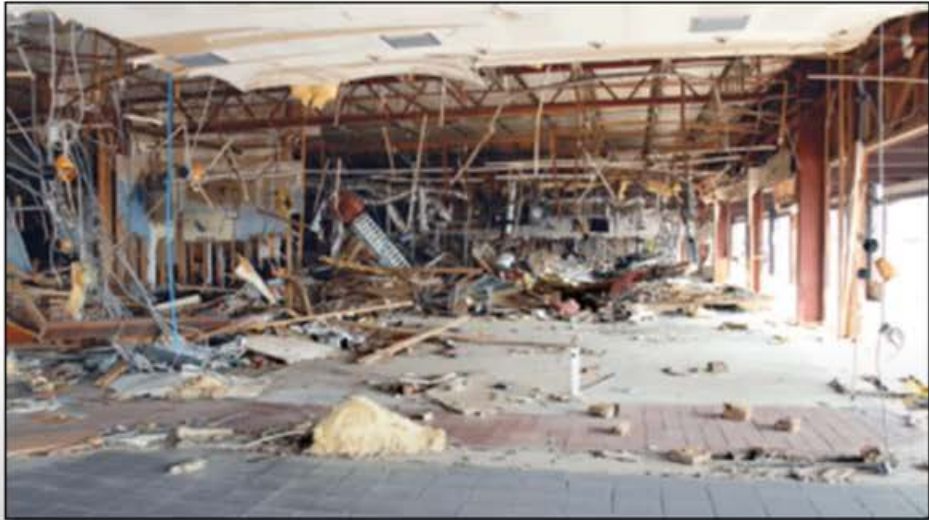
50-75% Damage (6" to 3' above FFE)

**Replace baseboards and door casings;
repair or replace walls or trim**

Over 75% Damage (Over 3' above FFE)

**Replace baseboards, door casings, walls and
trim; complete repainting**

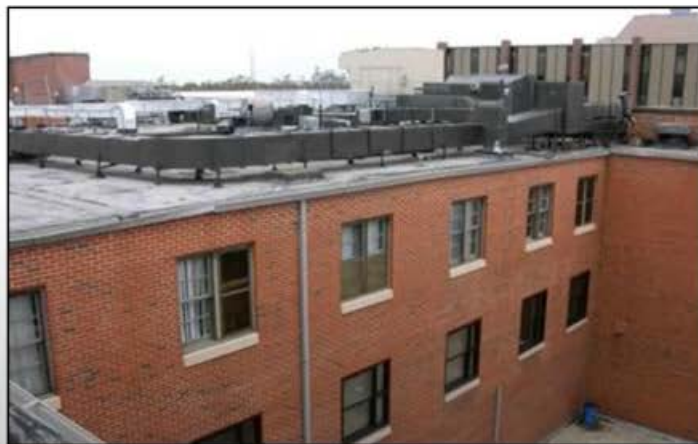
0-25% Damage

Minor roof covering damage,
no visible roof sheathing damage

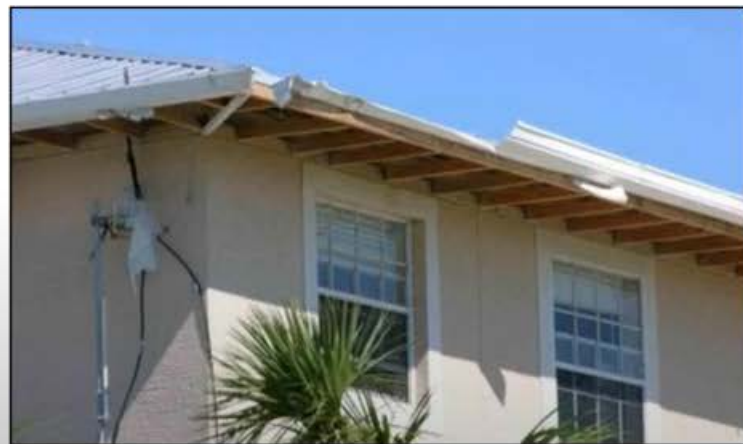
25-50% Damage

More roof covering damage,
minimal roof sheathing damage

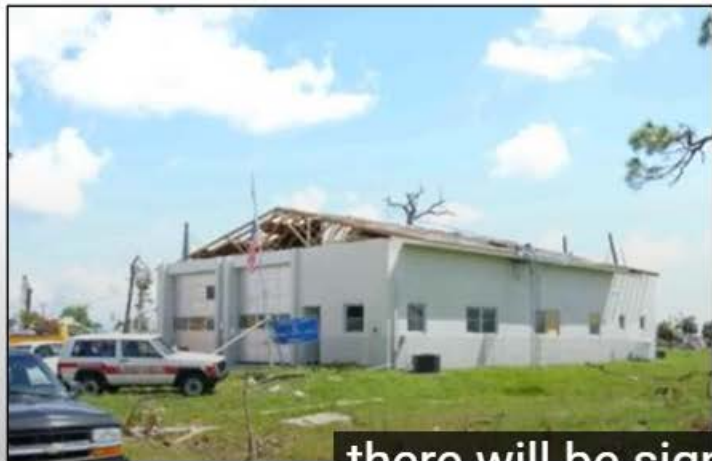
50-75% Damage

Significant roof covering and roof sheathing damage

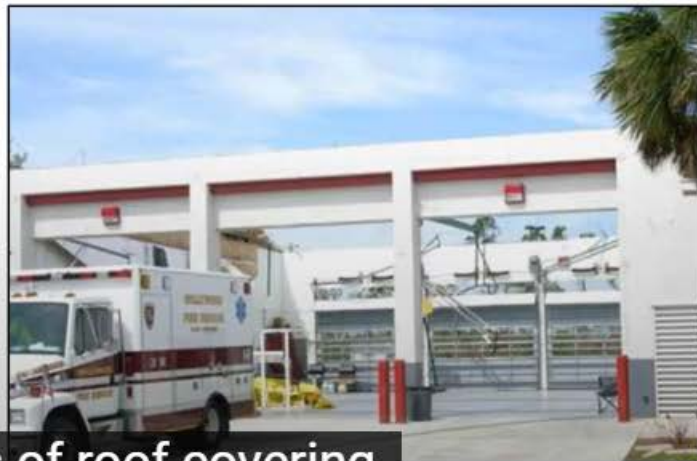
Over 75% Damage

Extensive damage, missing wall/roof framing, open walls; significant evidence of framing deformation or distortion

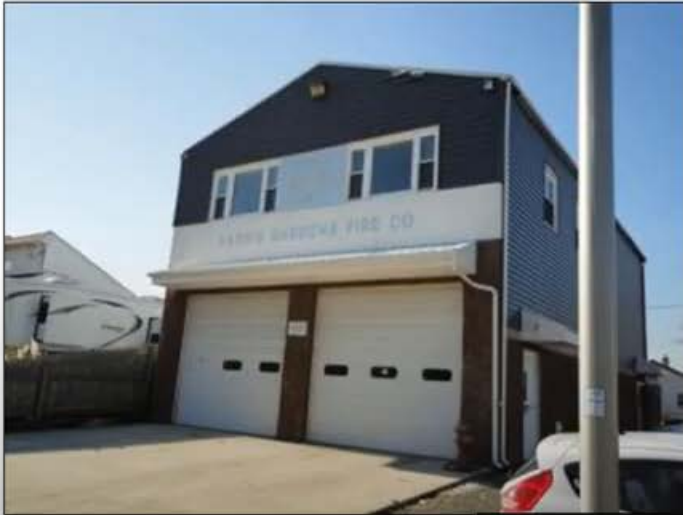
0-25% Damage (just below FFE)

**Minor wall damage,
no deformation or distortion of framing**

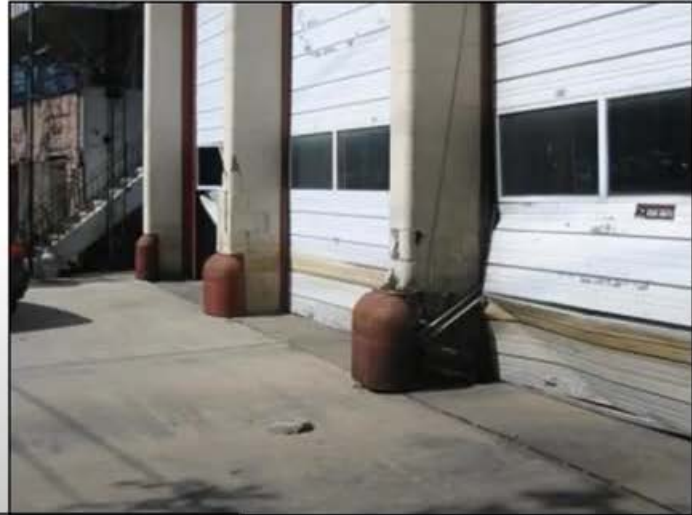
25-50% Damage (0" to 12" above FFE)

**Some wall damage,
no major deformation or distortion**

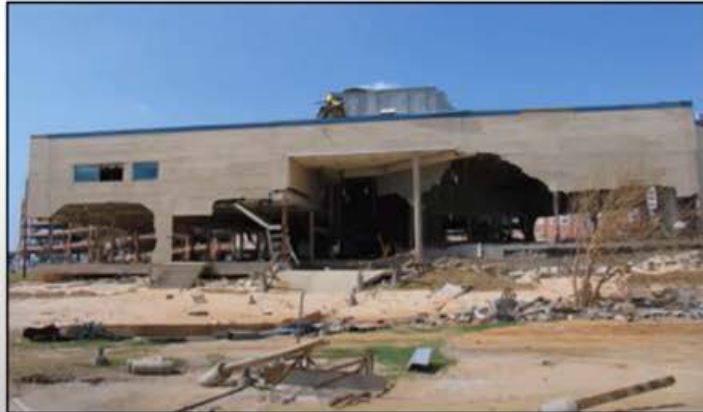
50-75% Damage (1' to 3' above FFE)

More damage to wall/roof framing;
some evidence of framing deformation or
distortion, significant surge/wave damage,
visible structural issues

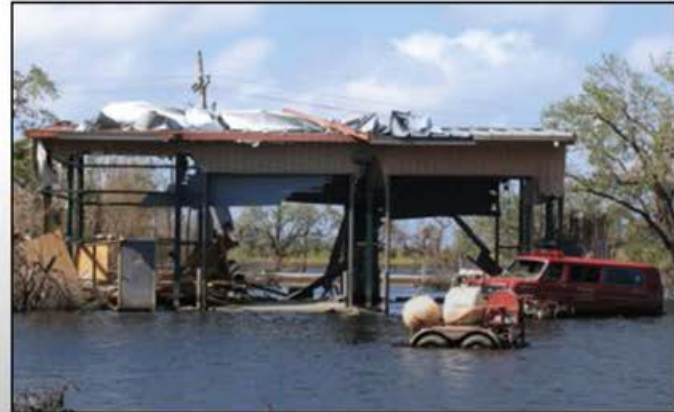
Over 75% Damage (Over 3' above FFE)

Extensive damage, missing wall/roof framing,
open walls; significant evidence of framing
deformation or distortion, major surge/wave
damage, partial or complete structural collapse
