Basic Flooding Model Assumptions:

- 1) Medium height freshwater flooding; limited duration. No high-velocity action; no wave action.
- 2) A 1-story house (without a basement) is used for this example house to establish the Categories of Work percentages of total costs.

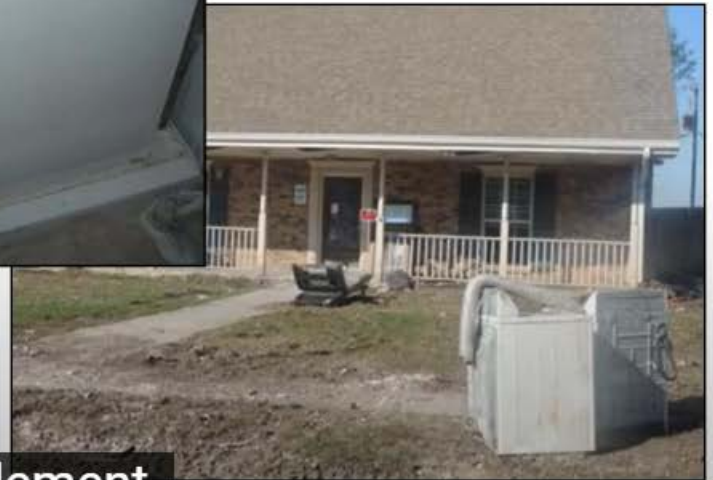
25-50% Damage (6" to 12" above FFE)

Increased damage, some floor appliances unusable

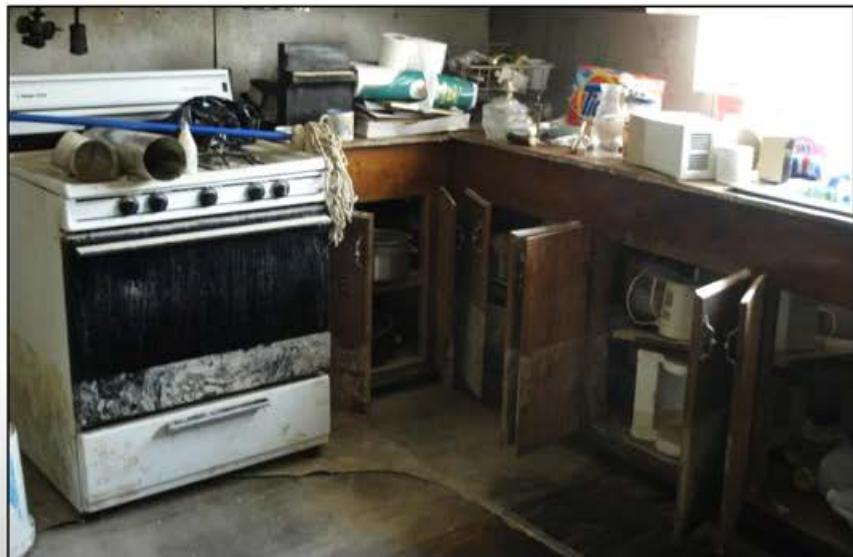
Over 75% Damage (Over 18" above FFE)

Most or all built-in appliances need replacement

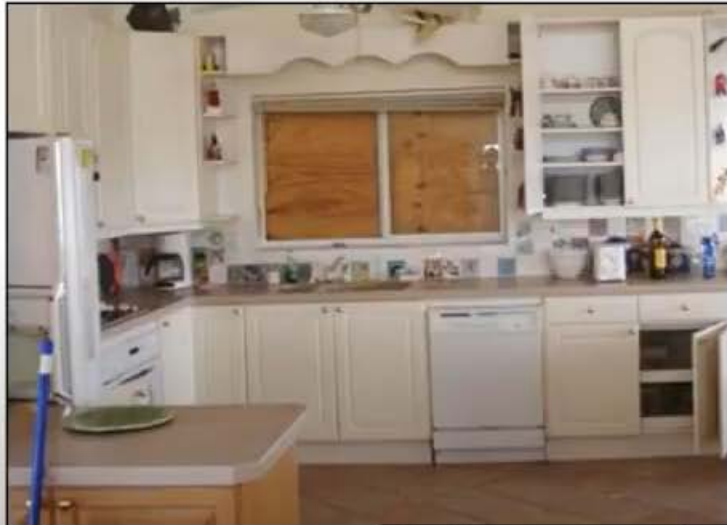
0-25% Damage (Up to 4" above FFE)

Minimal damage to base cabinets

<p>Common Damage</p> <p>Base cabinets have minimal water damage. Swelling and deterioration of manufactured case goods, especially cabinet bases, sides, and drawers using engineered wood products. Bathroom vanity cabinets and kitchen base cabinets may need cleaning, sanitizing, and limited repairs. Repainting will be required to match upper cabinets in kitchen.</p>	<p>Base cabinets of particleboard or medium-density fiberboard need to be replaced. Repaint to match upper cabinets in kitchen. Wood and plywood base cabinets may need cleaning, sanitizing, and some repairs at cabinet base. Repainting will be required to match upper cabinets in kitchen.</p>	<p>Replace base cabinets. Water damage and exposure is prolonged - deformation, delamination, and warping of cabinet base drawers and doors. Water contains debris and contaminants. The countertops may need to be replaced.</p>	<p>Replace base cabinets and upper wall cabinets. Water damage and exposure is prolonged - deformation, delamination, and warping of cabinet base drawers and doors. Water contains debris and contaminants. The countertops will need to be replaced.</p>

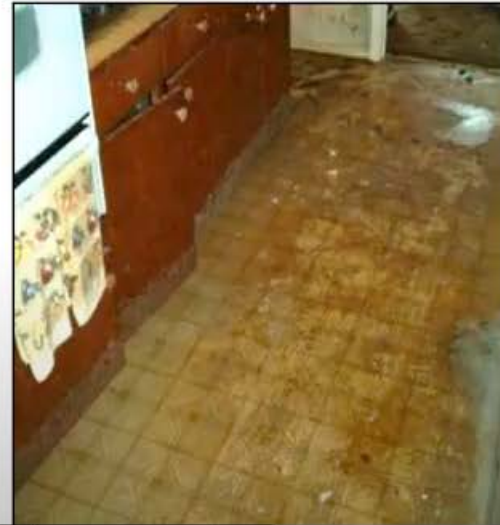
25-50% Damage (4" to 12" above FFE)

**Increased damage to base cabinets,
possibly some damage to counters**

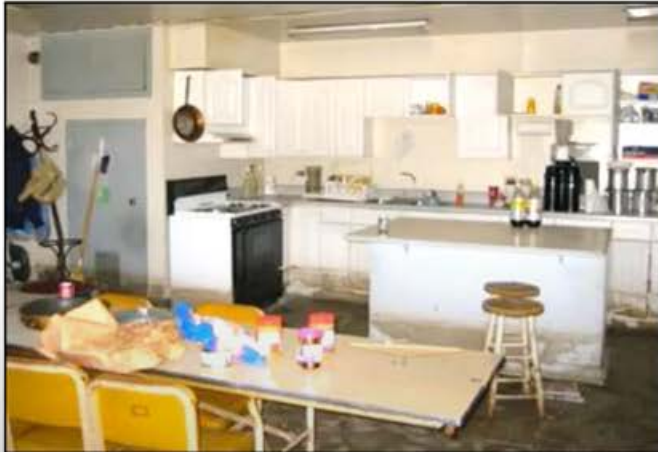
50-75% Damage (12" to 3' above FFE)

**Replace base cabinets
and possibly counters**

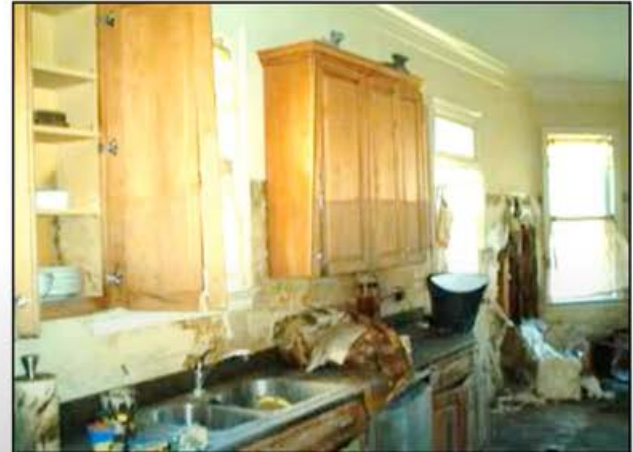
Over 75% Damage (Over 3' above FFE)

**Replace base cabinets,
counters, and wall cabinets**

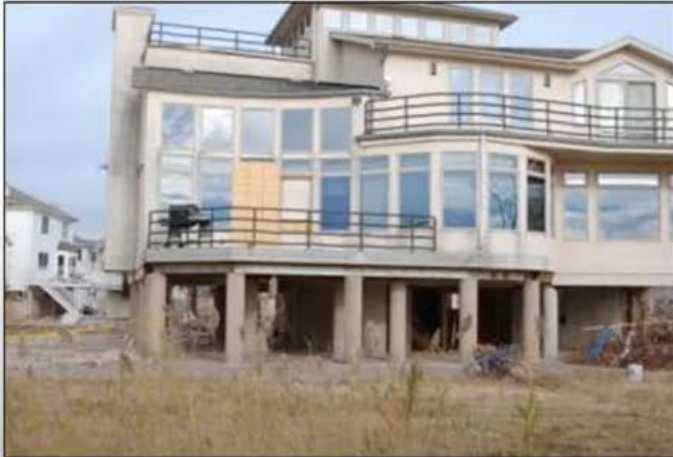
0-25% Damage (Just below FFE)

Bottoms of interior doors may be deformed, delaminated or swelled, one or two windows blown out

<p>Common Damage</p> <p>Bottoms of some interior doors may be deformed, delaminated, or have some swelling damage. Doors may need adjustment and/or repairs to close and latch properly. No impact on normal sill-height windows. Damage may be found at floor-level windows (hopper windows, awning windows, and floor-to-ceiling windows).</p>	<p>Bottoms of interior and exterior doors may be deformed, delaminated or have some swelling damage. Doors may need adjustment and/or repairs to close and latch properly. No impact on normal sill-height windows. Damage may be found at floor-level windows (hopper windows, awning windows and floor-to-ceiling windows).</p>	<p>Bottoms of interior and exterior doors will be deformed, delaminated, or have some swelling damage. Interior doors will likely need replacement. Exterior doors may need adjustment, repairs, or replacement. No impact on normal sill-height windows. Repairs or replacements may be needed at floor-level windows (hopper windows, awning windows, and floor-to-ceiling windows).</p>	<p>Bottoms of interior and exterior doors will be deformed, delaminated, or have some swelling damage. Interior and exterior doors will likely need replacement. Deformation or other damage will be found at normal sill-height windows. Replacement will be necessary at floor-level windows (hopper windows, awning windows, and floor-to-ceiling windows). Replacement may be necessary for other windows.</p>

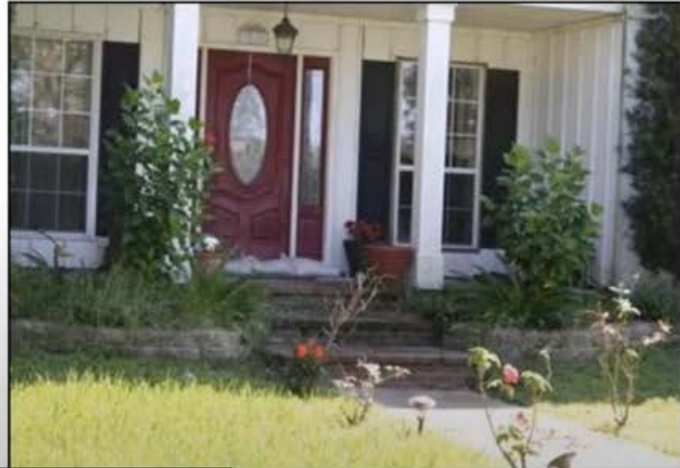
25-50% Damage (0" to 6" above FFE)

Several doors or windows damaged, some cleaning from floodwaters required on doors/windows

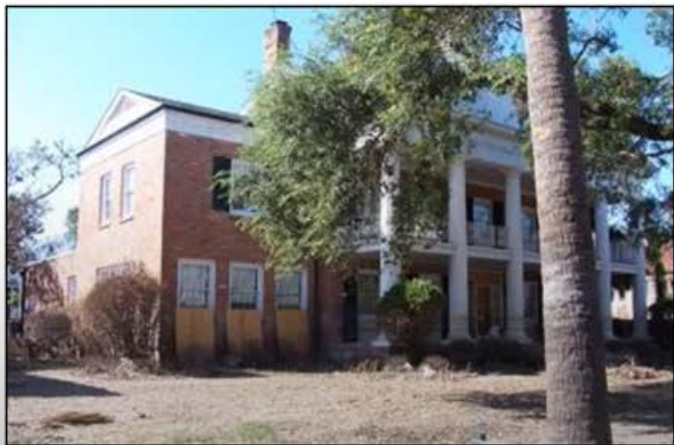
50-75% Damage (6" to 12" above FFE)

Doors replaced, multiple windows need to be replaced from wind damage

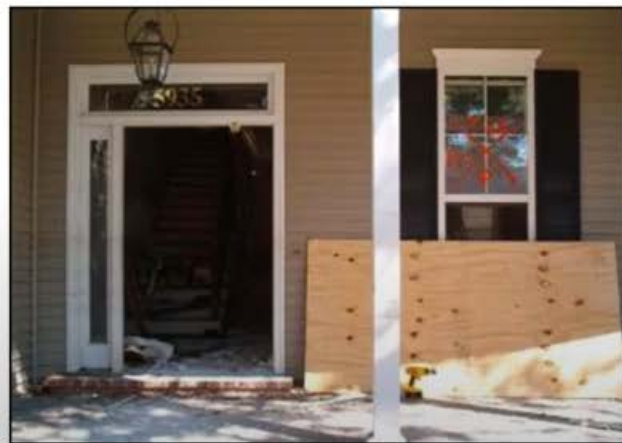
Over 75% Damage (Over 12" above FFE)

Interior and exterior doors likely need replacement; deformation and other damages at normal sill-height windows

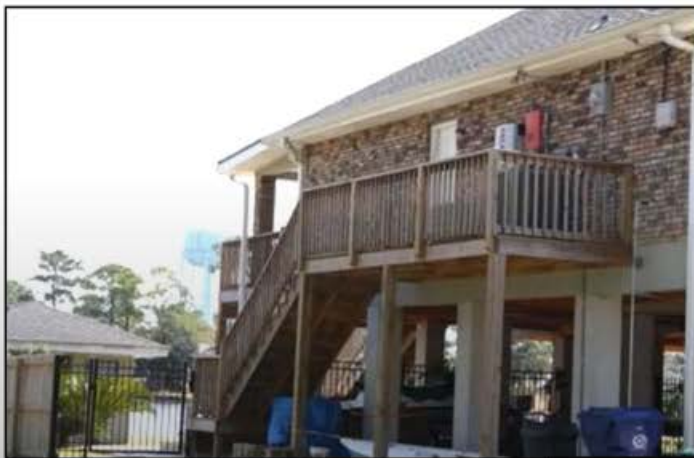
0-25% Damage (Up to 12" above FFE)

Minor electrical components and limited wiring inundated, flooding below normal receptacle/outlet height

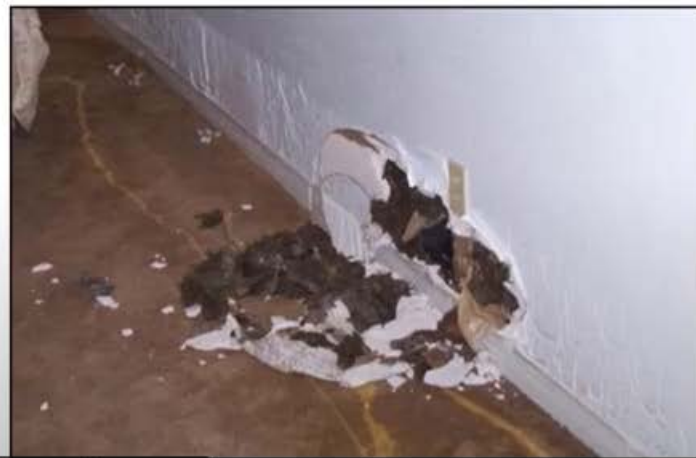
25-50% Damage (12" to 18" above FFE)

Receptacles impacted, major components of the electrical system not affected

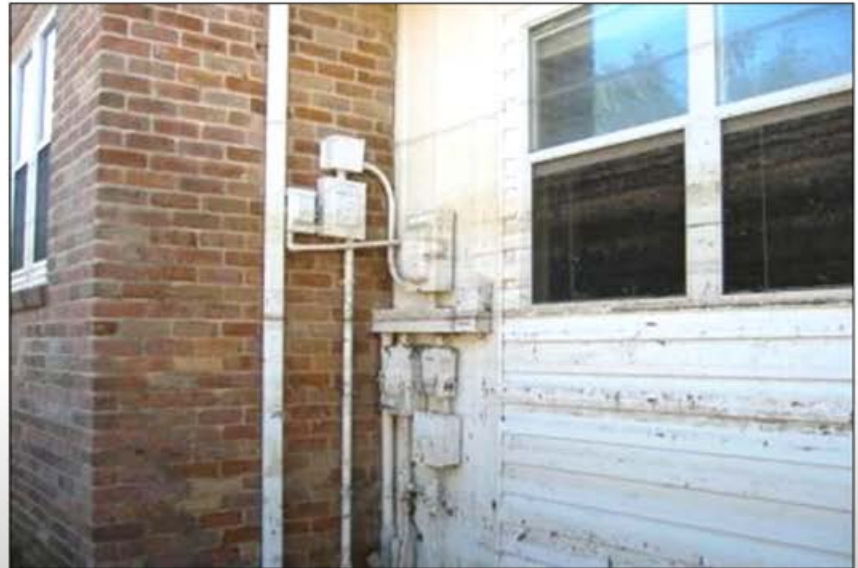
Over 75% Damage (Over 3' above FFE)

**Most wiring components and significant
amount of electrical system is inundated
and needs replacement**

High water marks over 3 feet

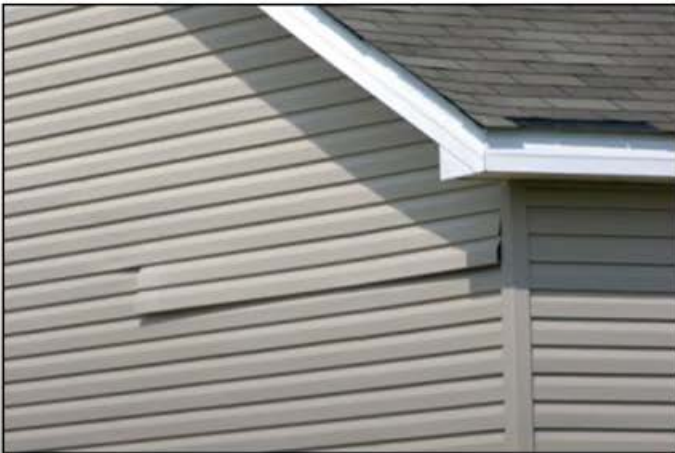
0-25% Damage (Up to 6" above FFE)

Water staining, cleaning, some water removal of brick/stone veneer walls; minor siding repairs from wind damage

<p>Common Damage</p> <p>Water staining, contamination, and damage on some of the exterior wall finishes. 'Clean and repair' process is likely. Brick and stone veneer walls, stucco walls, and 'cultured stone' walls may need some water removal techniques to allow drying of the interior materials and wall cavities. Verify adherence of the finish materials to the wall substrate. A limited amount of the siding materials may require replacement as needed. No damage or replacement of the insulation system is necessary, except where water and high moisture conditions have caused the insulation to fall loose within the crawlspace sub-flooring.</p>	<p>Damage/losses to some areas of the exterior wall surfaces, in addition to water staining and contamination. Some repairs are required at damaged locations prior or during 'clean and repair' process. Brick and stone veneer walls, stucco walls, and 'cultured stone' walls may need some water removal techniques to allow drying of the interior materials and wall cavities. Verify adherence of the finish materials to the wall substrate. Damaged house trim work will require replacement. Water damage to the insulation in the sub-flooring above the crawlspace or basement levels. Damage to insulation is evident and insulation often has fallen loose. This insulation should be removed and replaced.</p>	<p>Damage/losses to significant sections of the exterior wall surfaces, in addition to water staining and contamination. Significant repairs are required at damaged locations prior to 'clean and repair' process. Replacement of some sections of the exterior siding is required. Brick and stone veneer walls, stucco walls, and 'cultured stone' walls may need some water removal techniques to allow drying of the interior materials and wall cavities. Verify adherence of the finish materials to the wall substrate. Water damage to the insulation in the sub-flooring above the crawlspace or basement levels. This insulation should be removed and replaced. Water saturation of wall insulation may be found in the lowest section of the exterior walls. Contaminants in the flood waters are cause for removal and replacement of lower sections of the saturated insulation. Clean, sanitize, and dry the structural systems before re-installing materials. Damaged house trim work will require replacement, especially at door and window casings.</p>	<p>Damage/losses to major sections of the exterior wall surfaces, in addition to water staining and contamination. Major repairs are required at damaged locations prior to 'clean and repair' process. Replacement of large sections of the exterior siding is required. Brick and stone veneer walls, stucco walls, and 'cultured stone' walls may need some water removal techniques to allow drying of the interior materials and wall cavities. Verify adherence of the finish materials to the wall substrate. Damaged house trim will require replacement, especially at door and window casings. Water damage to the insulation in the sub-flooring above the crawlspace or basement levels. This insulation should be removed and replaced. Water saturation of wall insulation requires the removal of all of the insulation from the damaged sections of the exterior walls. Contaminants in the flood waters are cause for removal and replacement of lower sections of the saturated insulation. Clean, sanitize, and dry the structural systems before re-installing.</p>

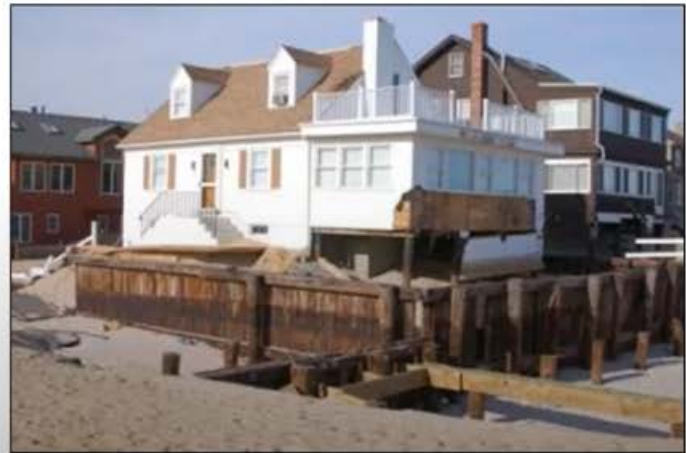
25-50% Damage (6" to 18" above FFE)

Some wall surface damage, some repairs needed to siding

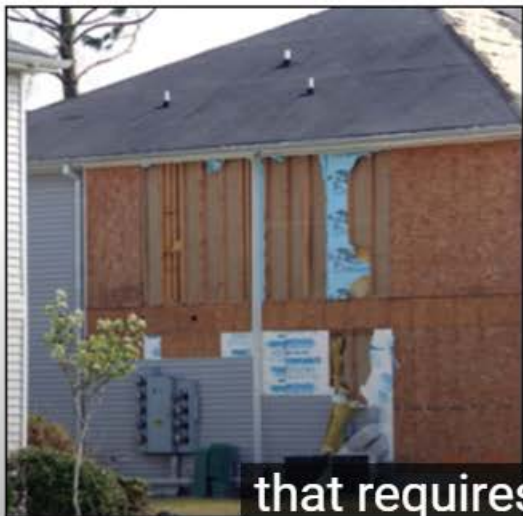
50-75% Damage (18" to 3' above FFE)

Damages/losses to significant sections of exterior wall surfaces, highly visible damage to exterior

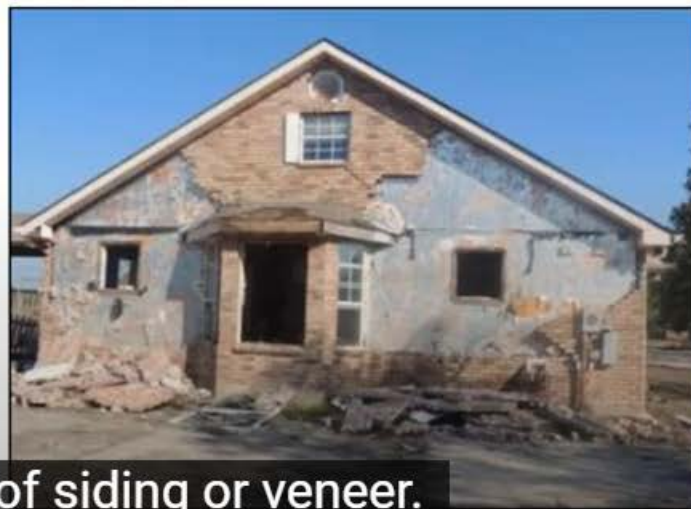
Over 75% Damage (Over 3' above FFE)

Extensive damages/losses of exterior wall surfaces, major repairs to wall surfaces, possibly accompanied by structural damage

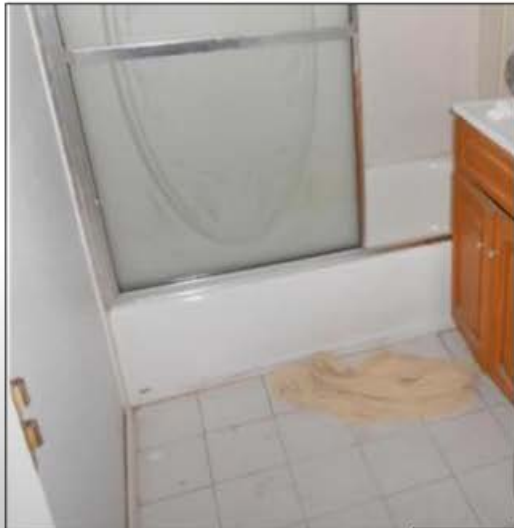
0-25% Damage

Tile floors that may only need cleaning

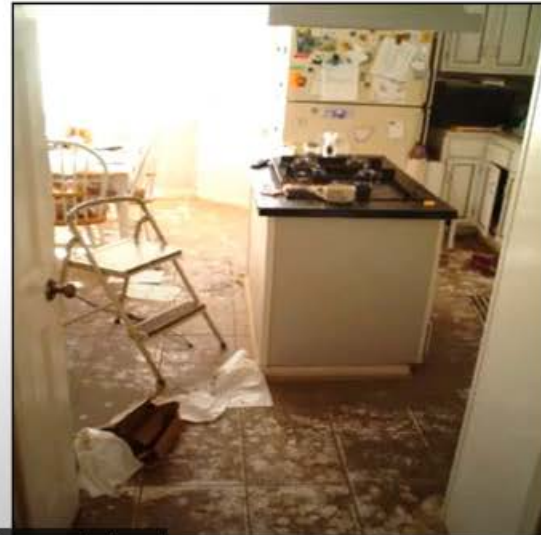
25-50% Damage

Only certain rooms/areas damaged or major cleaning efforts are needed

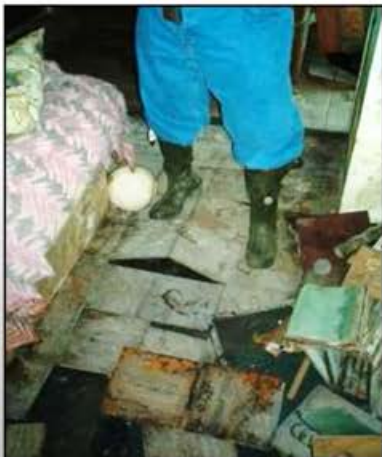
50-75% Damage

Floor coverings damaged in most areas,
major damage, some floors
will not need to be fully replaced

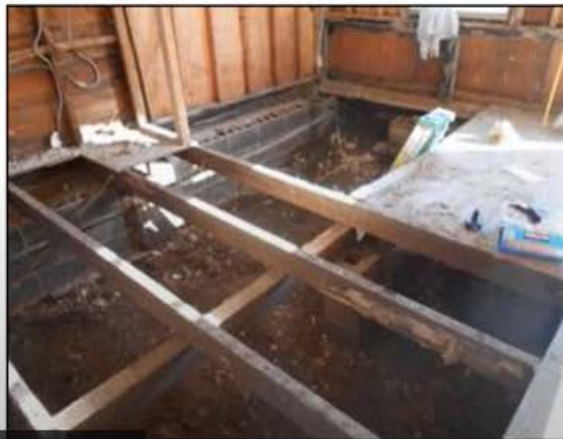
Over 75% Damage

Major damages to floor sheathing; most or all
floor coverings require replacement,
major surge/wave damage to floors,
partial or complete collapse

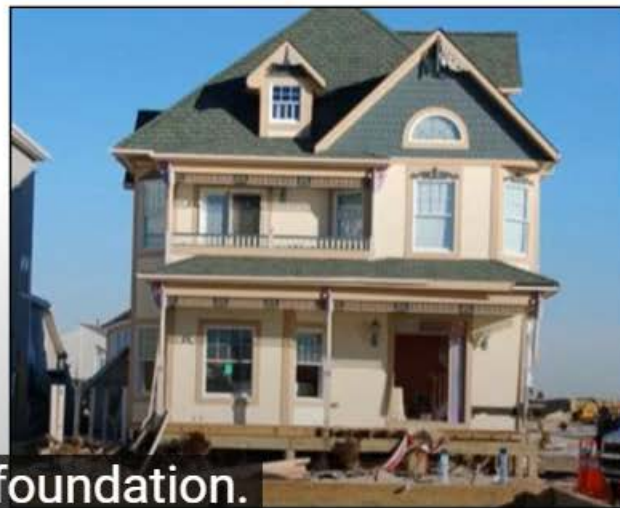
25-50% Damage (6" to 4' above FFE)

Limited scour, erosion, undermining, cracking;
No displacement of slab/walls;
No damage/destruction of elements located below elevated floor

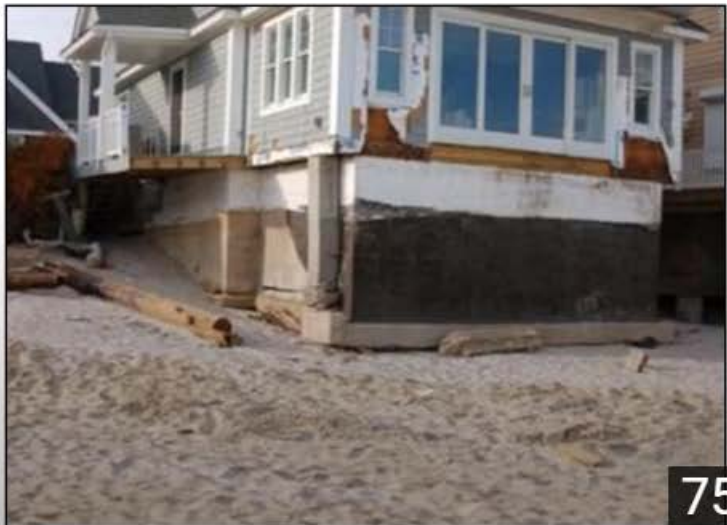
50-75% Damage (4' to 7' above FFE)

Limited scouring, some noticeable cracks in slab, significant surge/wave damage, visible structural issues

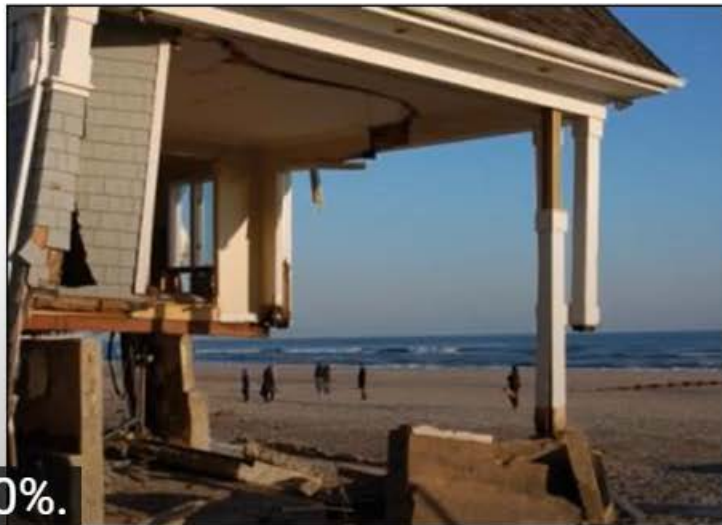
Over 75% Damage (over 7' above FFE)

Foundations cracked, displaced/missing, major surge/wave damage, partial or complete structural collapse

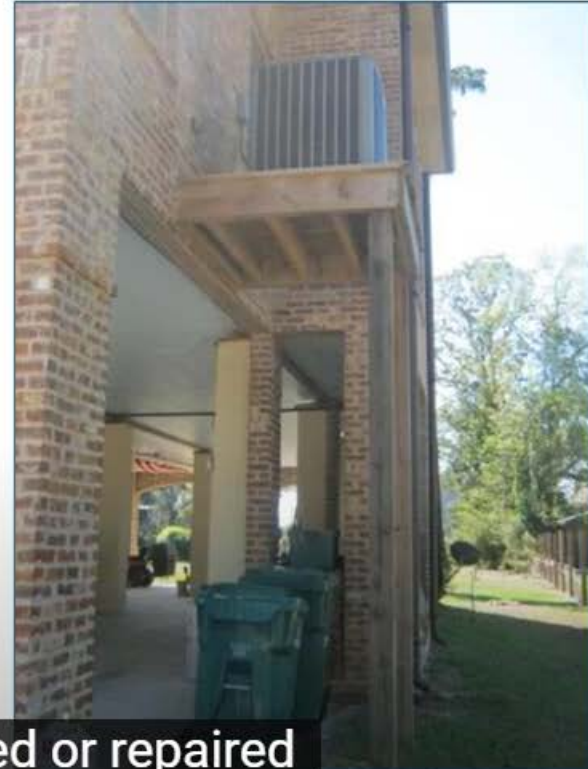
25-50% Damage (6" to 12" above FFE)

**Damage/destruction to HVAC equipment/ducts
at or near grade**

Common Damage	<p>If HVAC equipment (furnace, air handler, heat pump) are located in the basement or the under floor areas, the equipment should be reconditioned or replaced. Water-inundated duct insulation should be removed and replaced. If the duct insulation is integral to the ducts (duct board or secured interior duct liners), the ducts should be replaced. All ducts that are being reused will require cleaning.</p>	<p>If portions of the HVAC equipment (furnace, air handler, heat pump) are located in the basement or the under floor areas, the equipment should be reconditioned or replaced. Water-inundated duct insulation should be removed and replaced. If the duct insulation is integral to the ducts (duct board or secured interior duct liners), the ducts should be replaced. All ducts that are being reused will require cleaning.</p>	<p>Portions of the HVAC equipment (furnace, air handler, heat pump) should be replaced. Water-inundated duct insulation should be removed and replaced. If the duct insulation is integral to the ducts (duct board or secured interior duct liners), the ducts should be replaced. All ducts that are being reused will require cleaning.</p>	<p>All HVAC equipment (furnace, air handler, heat pump) should be replaced. Water-inundated duct insulation should be removed and replaced. If the duct insulation is integral to the ducts (duct board or secured interior duct liners), the ducts should be replaced. All ducts that are being reused will require cleaning.</p>

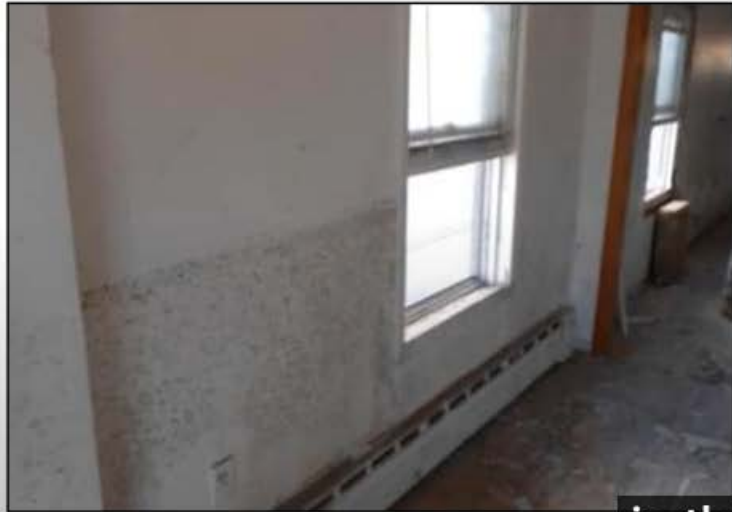
50-75% Damage (12" to 3' above FFE)

Portions of HVAC equipment replaced;
remove and replace inundated ducts, insulation

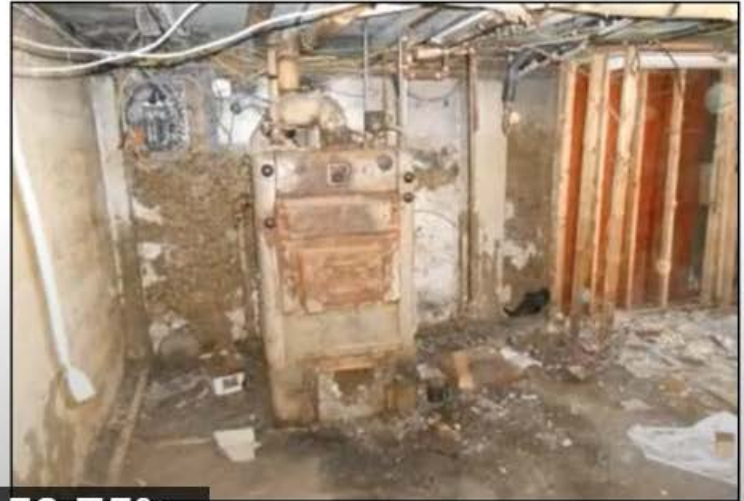
Over 75% Damage (Over 3' above FFE)

All HVAC equipment, inundated ducts,
and duct insulation replaced

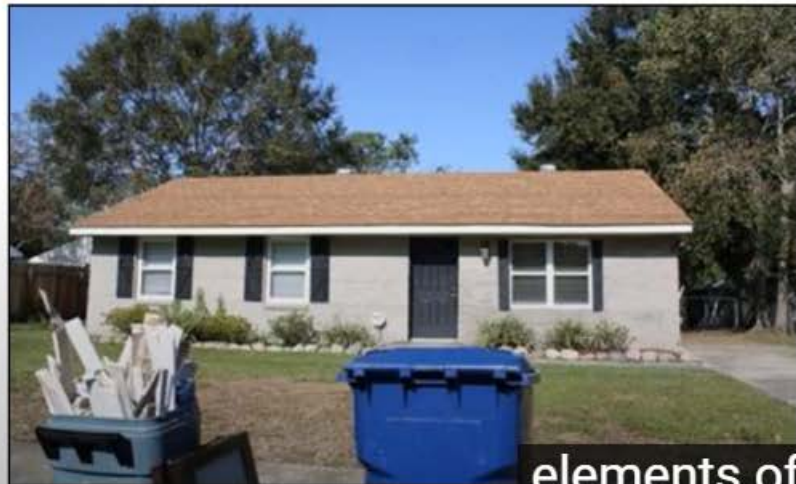
0-25% Damage (Just below FFE)

Possible water stains/damage at baseboard, bottoms of door casings, minor damage from rainwater infiltration

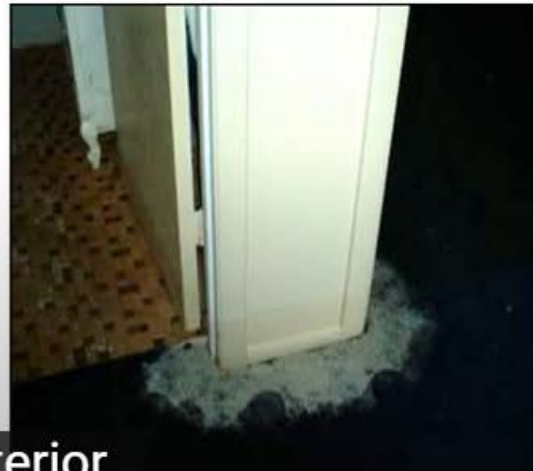
25-50% Damage (0" to 6" above FFE)

Likely water stains/damage, high water mark a few inches above first floor, some damage from rainwater infiltration or other damage limited to a few rooms

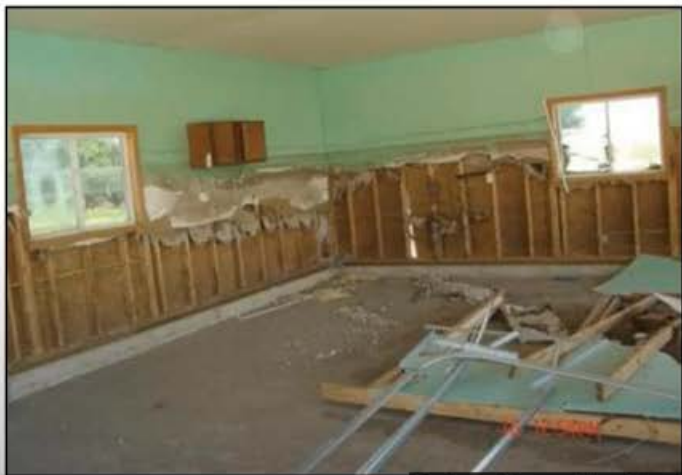
50-75% Damage (6" to 3' above FFE)

Replace baseboards and door casings; water damage at lower wall assemblies, repair or replace wall/trim

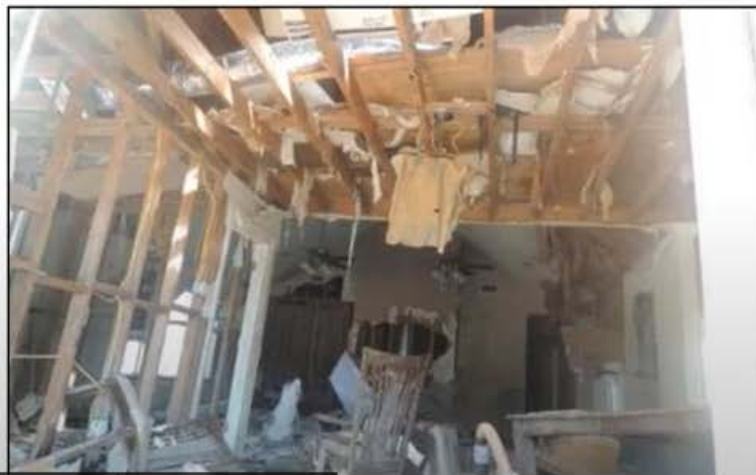
Over 75% Damage (Over 3' above FFE)

Replace baseboards, door casings, walls and trim; complete repainting; partial/complete structural collapse

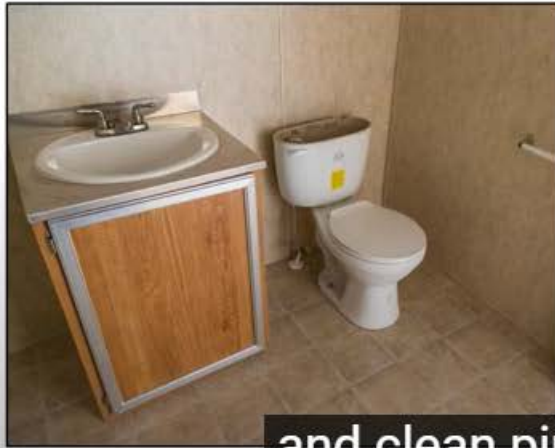
0-25% Damage (Up to 12" above FFE)

Backflow/contamination, fixture/piping damage may occur; sanitize any under floor/slab plumbing, minor damages to plumbing below elevated floor

<p>Common Damage</p> <p>Floor drains can backflow into the house. Under floor (or under slab) plumbing systems should be purged, cleaned, and sanitized. Any materials that might contain remnants of waste materials or other contaminants in the floodwaters will require replacement.</p>	<p>Floor drains, shower drains, bathtubs, and toilets can back flow into the house. Septic contamination is likely. The water heater may need to be replaced.</p>	<p>Floor drains, shower drains, bathtubs, toilets, bathroom sinks, utility sinks, and toilets will backflow into the house. Septic contamination will occur. The water heater will need to be replaced.</p>	<p>All plumbing fixtures will backflow into the house. Septic contamination will occur. The water heater will need to be replaced.</p>	
	<p>Special Considerations for Coastal/High Velocity Floods</p>	<p>Houses in coastal areas may have additional plumbing fixtures and piping on the exterior of the house.</p>

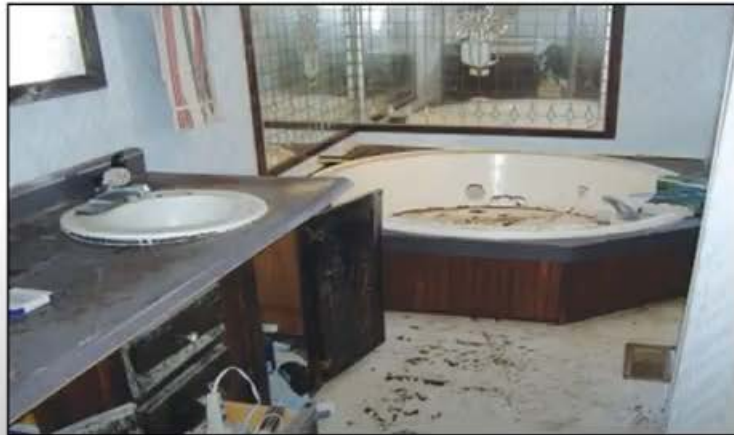
50-75% Damage (18" to 3' above FFE)

**Significant backflow/contamination;
replace water heater;
some fixture damage**

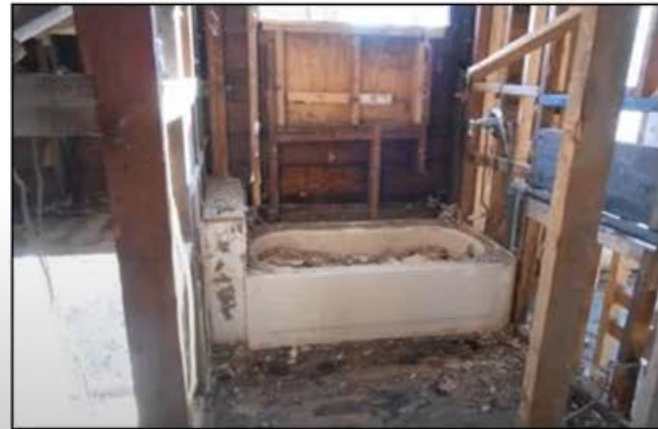
Over 75% Damage (Over 3' above FFE)

**Most or all plumbing fixtures
and piping contaminated/damaged**

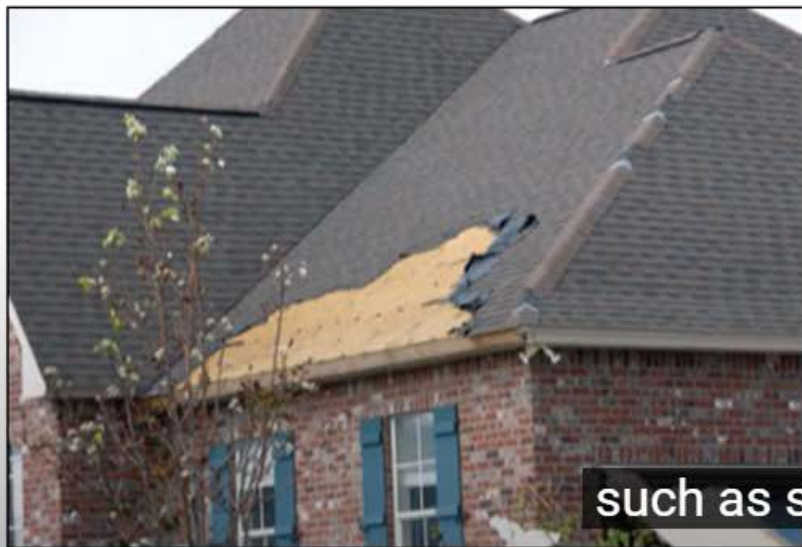
0-25% Damage

Minor roof covering damage,
no visible roof sheathing damage

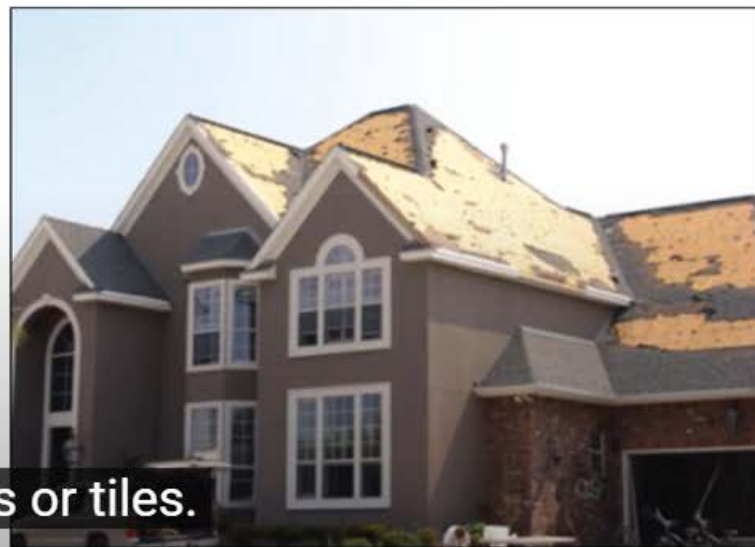
25-50% Damage

More roof covering damage,
minimal roof sheathing damage

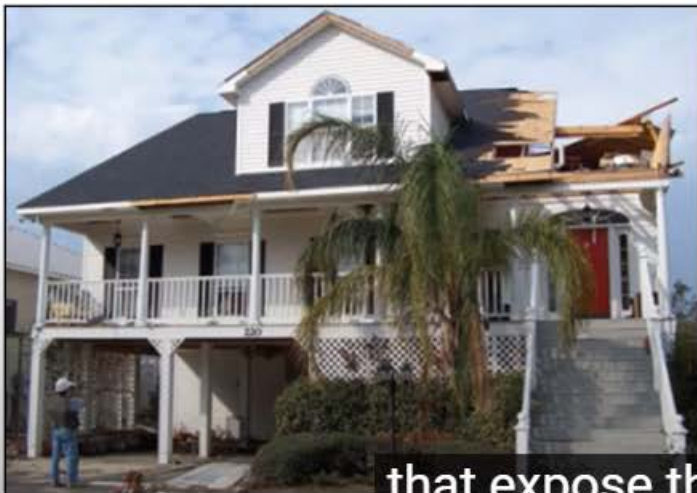
50-75% Damage
(varies based on wind conditions)

Significant roof covering and
roof sheathing damage

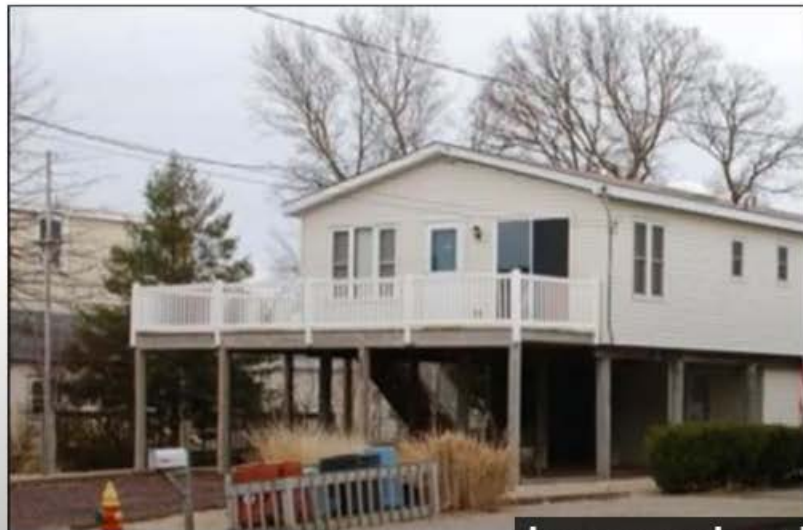
0-25% Damage (just below FFE)

Minor wall damage, but no deformation or distortion of framing

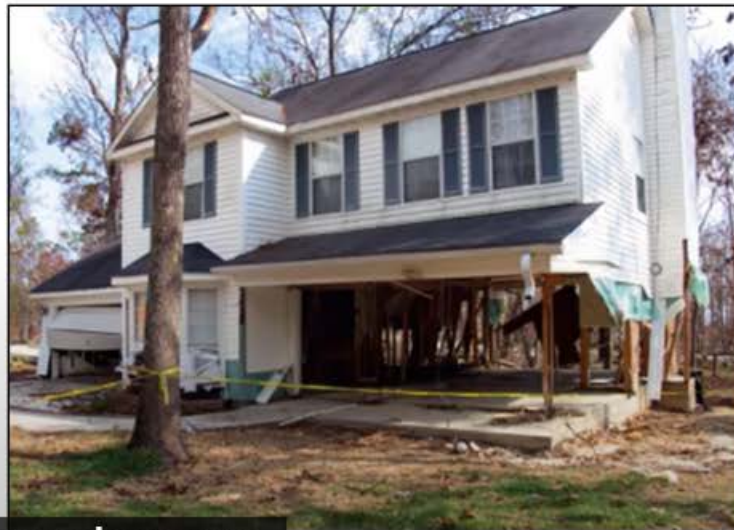
25%-50% Damage (0" to 12" above FFE)

Some wall damage, but no major deformation/distortion

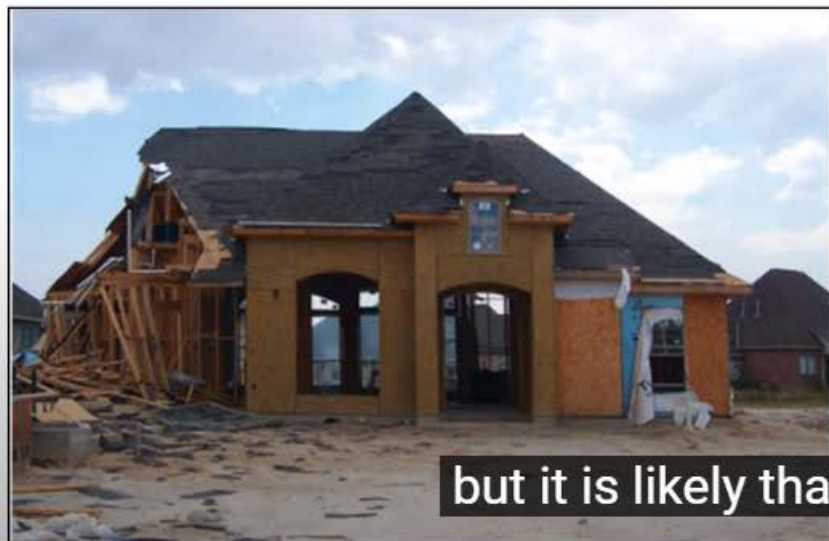
50-75% Damage (1' to 3' above FFE)

**More damage to wall/roof framing;
some evidence of framing deformation or
distortion, significant surge/wave damage,
visible structural issues**

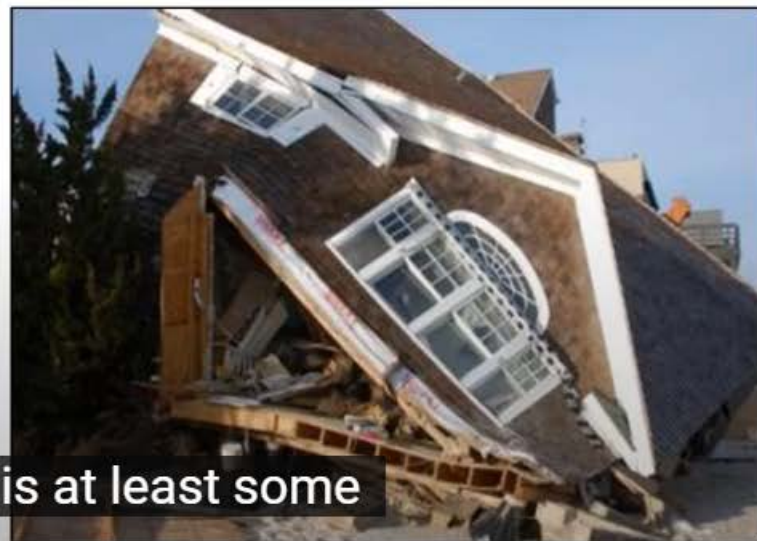
Over 75% Damage (Over 3' above FFE)

**Extensive damage, missing wall/roof framing,
open walls; significant evidence of framing
deformation or distortion, major surge/wave
damage, partial or complete structural collapse**
